# Manhole Inspection Summary

Manhole # S43Y\_\_004MH

Insp Date: **3/11/08 1:19 PM**

**Location** Address: **Latrobe Park next to rec center bldg** Cross Street: **E Fort Avenue**

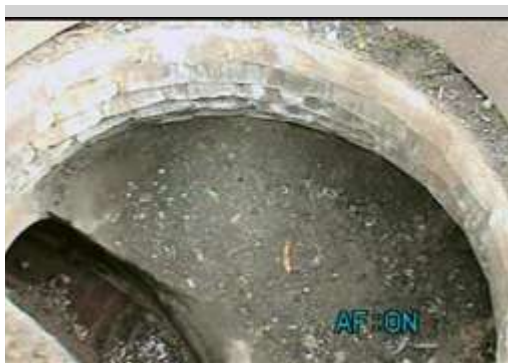
Defect 3

Condition: ☐ Sound ☐ Cracked ☐ Root Intrusion ☐ Loose Brick ☒ **Deteriorated**

Infiltration: ☐ None ☒ **Joint** ☐ Cracks ☐ Mortar ☐ Roots ☐ Wall

corbel\_deteriorated & infiltration

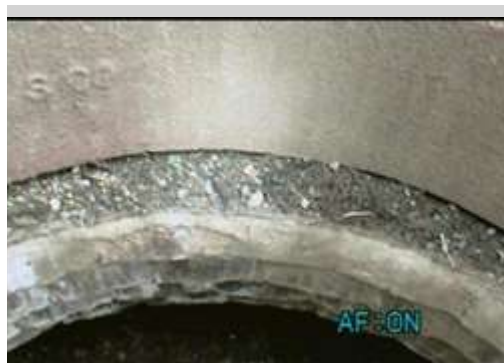
Defect 2

**Frame** Offset: **2** (in.) Condition: ☒ Sound ☐ Cracked ☐ Leaks

frame offset

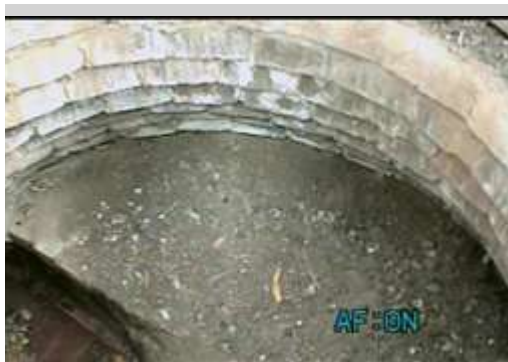
Defect 1

Condition: ☐ Sound ☐ Cracked ☐ Root Intrusion ☐ Deteriorated ☐ Leaks ☒ **Debris**

bench debris

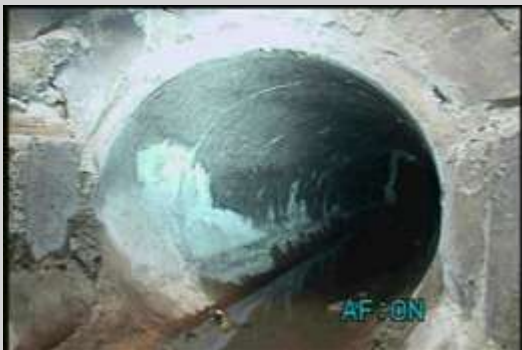
12 O'Clock Outflow

10 in. Circular Gravity Sewer  
Pipe Out @ 12 O'Clock

Pipe Material: **Clay** ☐ Pipe Lined

Invert Depth: **3.45** (ft.) Flow Characteristics: **None**

Deposits: ☒ None ☐ Mud ☐ Sludge ☐ Debris ☐ Grease

Infiltration: **None** Pipe Seal Cond: **Unknown**

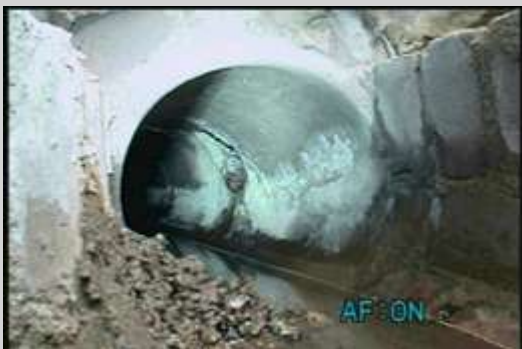
3 O'Clock Inflow

8 in. Circular Gravity Sewer  
Pipe In @ 3 O'Clock

Pipe Material: **Clay** ☐ Pipe Lined

Invert Depth: **3.40** (ft.) Flow Characteristics: **None**

Deposits: ☒ None ☐ Mud ☐ Sludge ☐ Debris ☐ Grease

Infiltration: **None** Pipe Seal Cond: **Unknown**
